RE: N00014-14-1-0789 Final Report

1. REPORT DATE (DD-MM-YYYY) 28-09-2017			2. REPORT TYPE Final		3. DATES COVERED (From - To) 01-07-2014 - 28-09-2017	
4. TITLE AND SUBTITLE Technology Insertion for Recapitalization of Legacy Systems Program Final Report					5a. CONTRACT NUMBER	
					5b. GRANT NUMBER N00014-14-1-0789	
					5c. PROGRAM ELEMENT NUMBER

Research Program 1:
Effect of Corrosion on Physical Properties
of Highly Stressed Coated Components

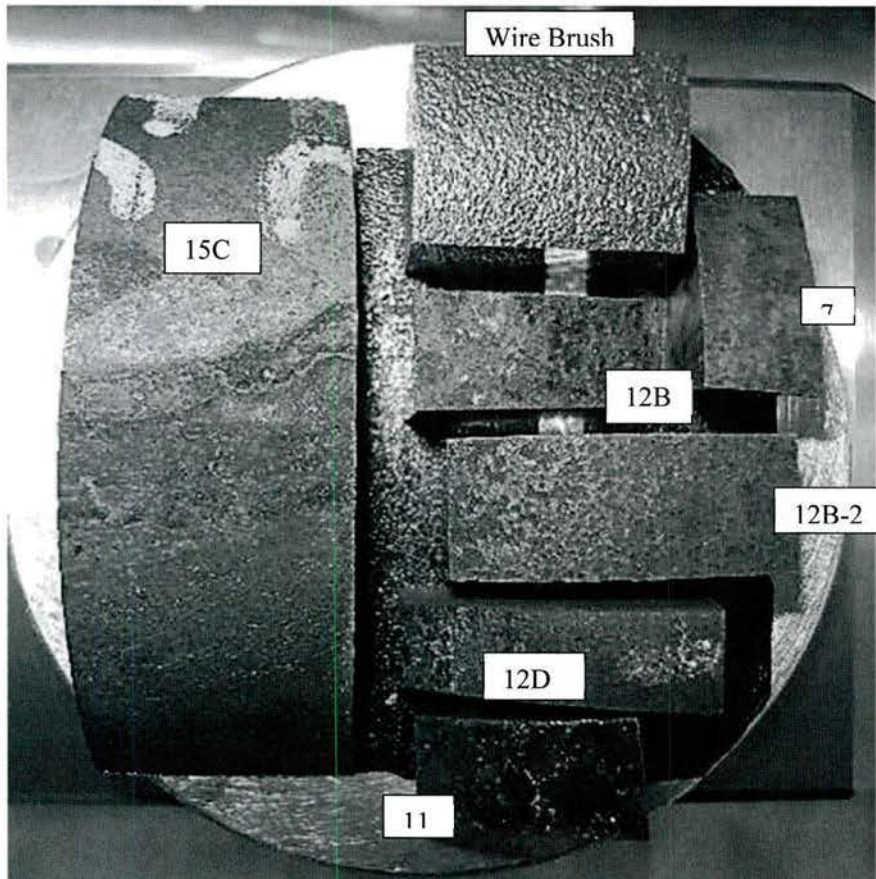
Samples for corrosion evaluation were cut from torsion bars labeled 12 (three sections), 15C, 7, and 11. Also included in this study was a sample from torsion bar 15 that had that the oxide removed by hand scrubbing with a wire brush. Figure 1 shows the torsion bars samples used for the SEM analysis.

Figure 1 - Corroded Torsion Bar Specimens Examined in SEM

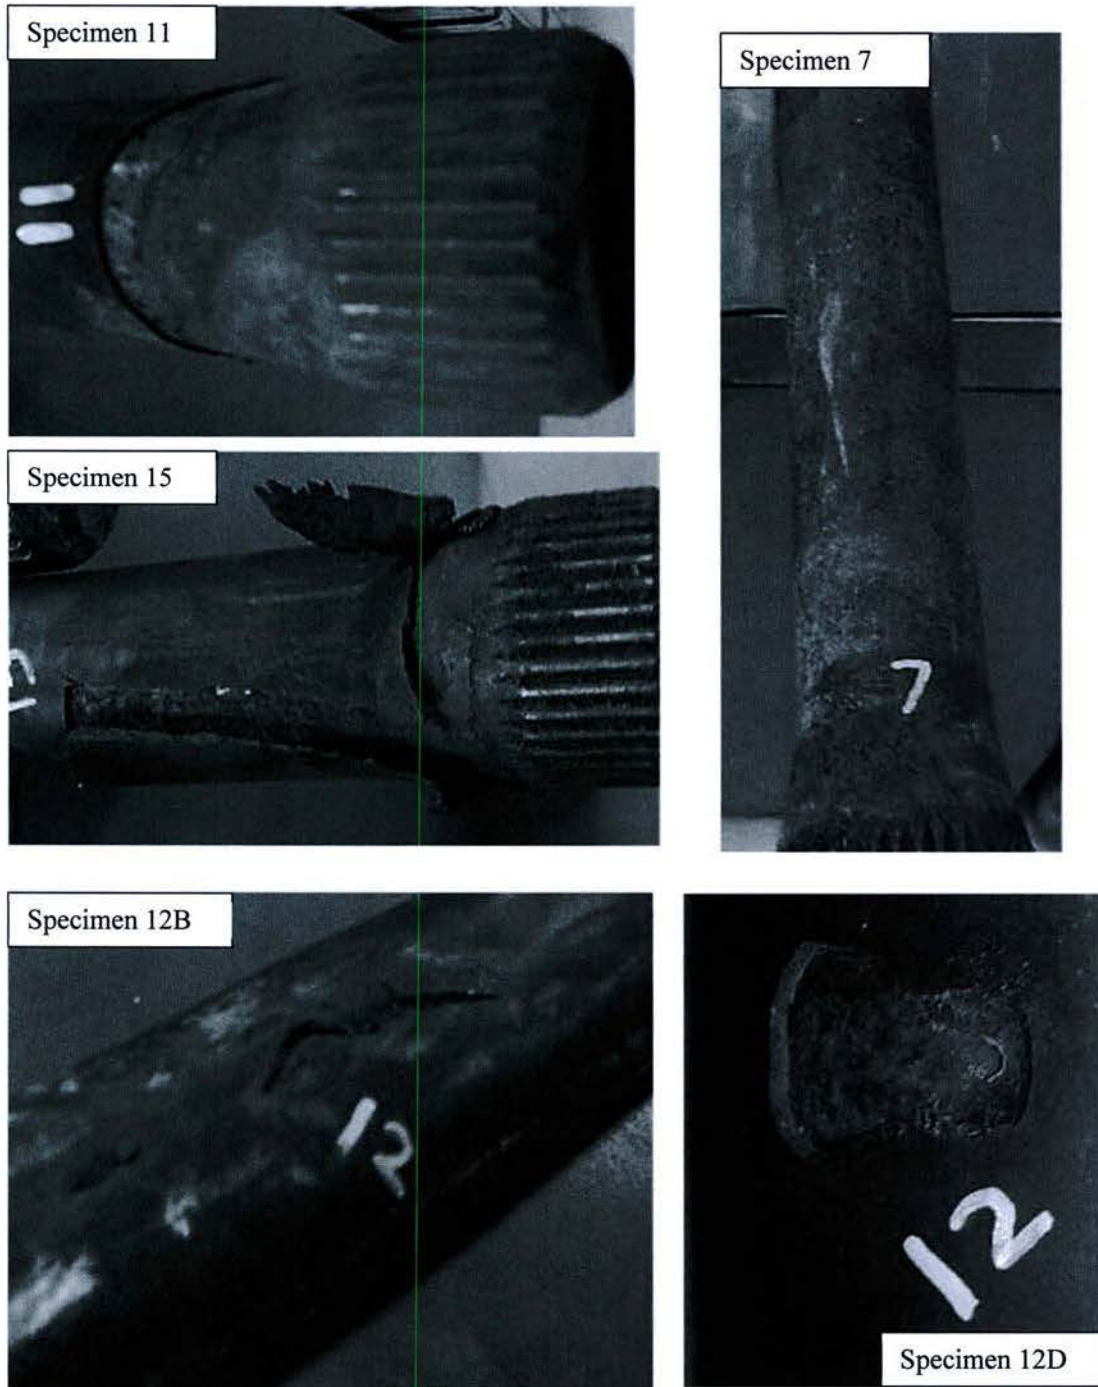
Figure 2 shows the locations on the torsion bars where the specimens were obtained. Specimen 11 was selected because the amount of corrosion on this torsion bar was similar to that observed on the majority of the rejected torsion bars observed at the Albany Maintenance Depot.

Figure 2 - Locations on Torsion Bars for Corrodes Torsion Bar Specimens Where Obtained

Typically, on these torsion bars the corrosion occurred at one end of the torsion bar, close to the spline, where the original coating had disbonded. Specimen 15 also exhibited corrosion close to the spline where the coating had disbonded but the coating disbond was greater on Specimen 15 than that observed on Specimen 11. In addition, there was a different corrosion pattern on the torsion bar in the region because the water penetrated beneath the disbonded coating. Specimen 7 was from a Gen 1 torsion bar and had the greatest amount corrosion observed on any torsion bar. Finally, the Specimens 12D, 12B and 12B-1 were taken from a torsion bar which experienced coating damage in a center region on the torsion bar where coating damage had occurred.

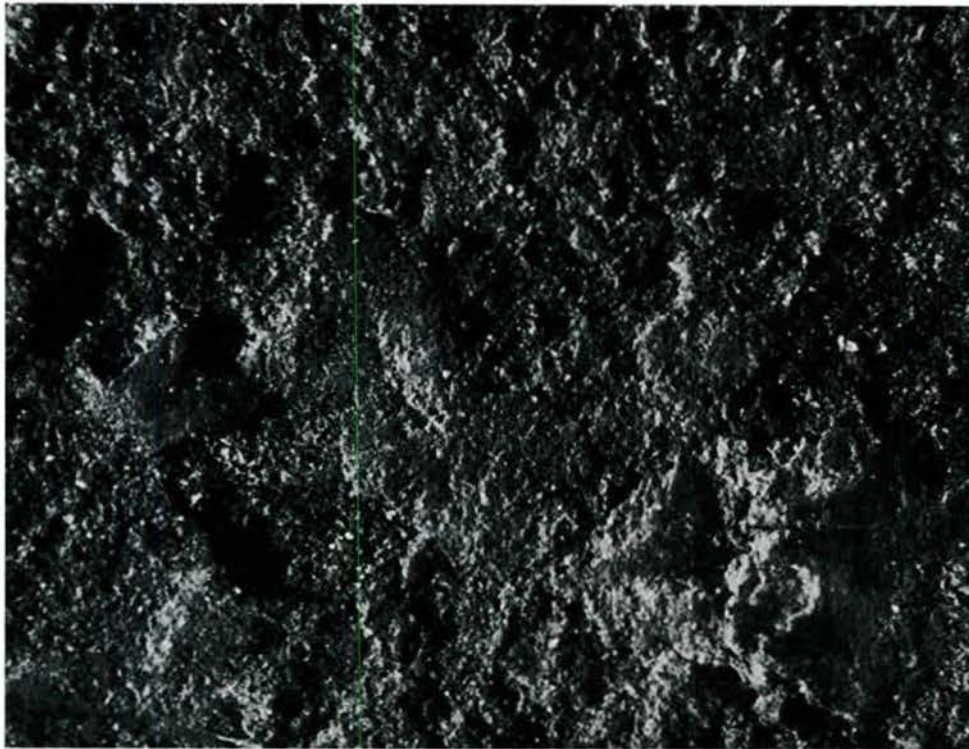
Figure 4 - Optical Photomicrograph of Surface of Specimen 7 (Mag 20x)

The severe corrosion on the Gen 1 torsion bar, Specimen 7 are illustrated in Figure 4-Figure 8. Both the optical and the SEM photomicrographs showed that the corrosion or oxide layer that developed on this specimen contained cracks (Figure 5) and pits (Figure 4 and Figure 8). The presence of both the pits and cracks are an indication that the oxide layer that developed was non-adherent. A non-adherent oxide layer will not act as a barrier and prevent or slow the formation of additional corrosion product on the surface of the torsion bar. As a result when a portion of the corrosion layer flakes from the surface the exposed metal will quickly oxidize.

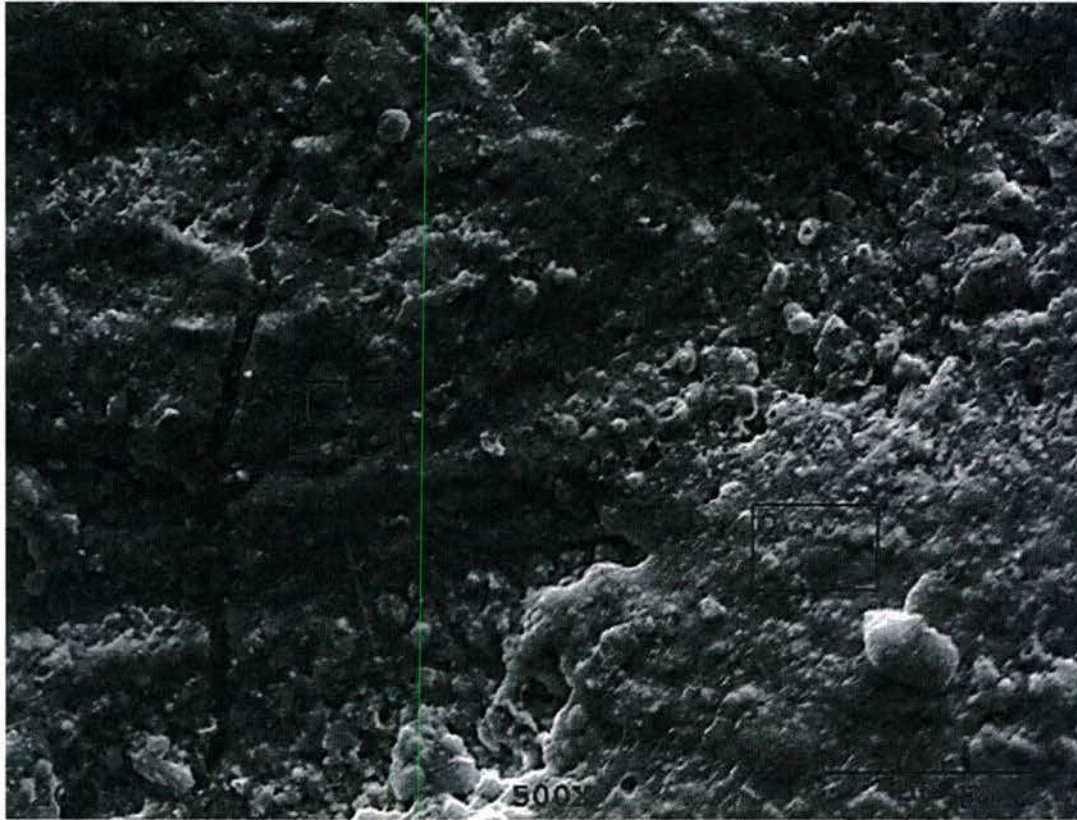
Figure 6 - Higher Magnification SEM Photomicrograph of Area within the Square in Figure 4 from Specimen 7 (Mag 500x)

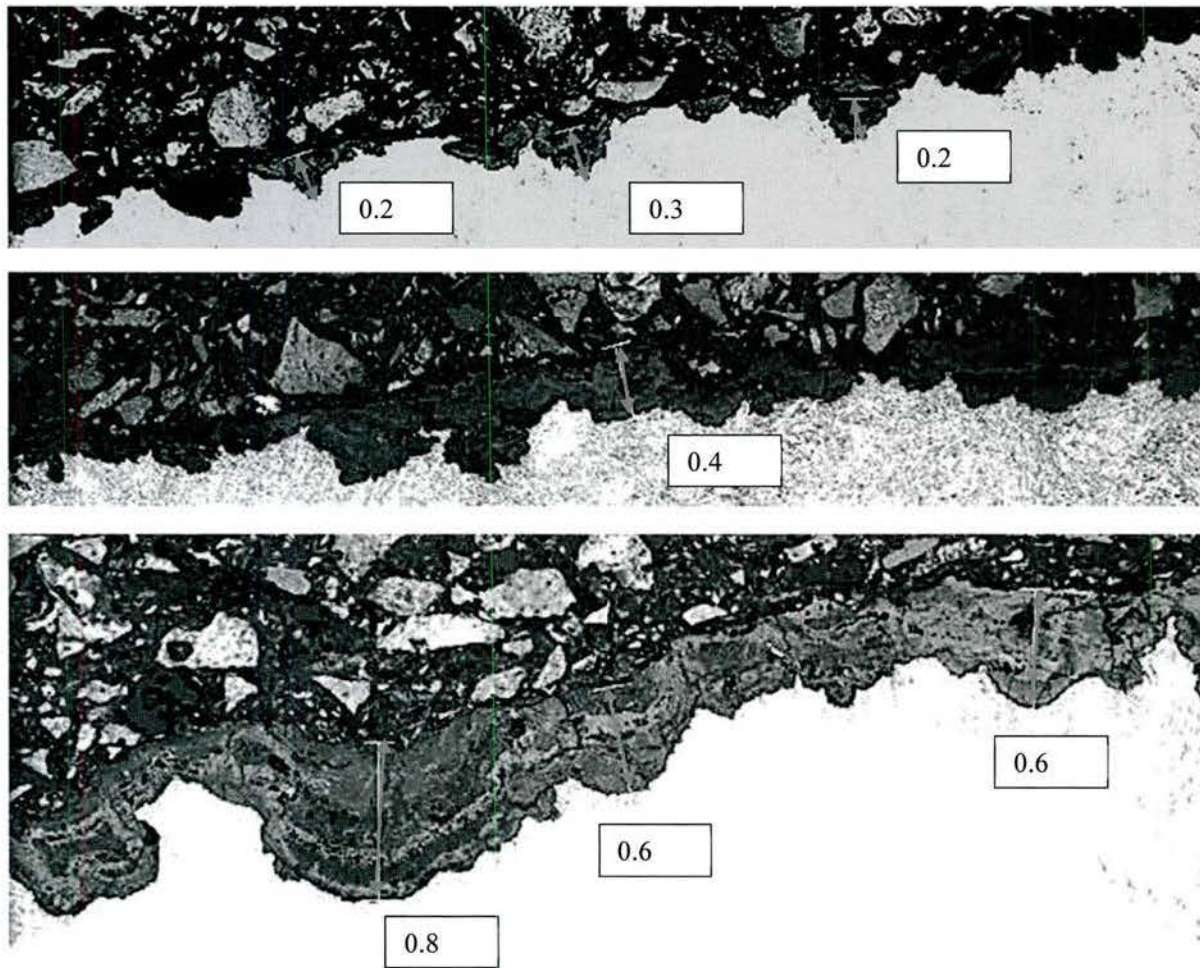
Figure 8 - Cross-Sectional Optical Photomicrographs of Oxide Layer That Developed on Three Regions on Specimen 7 (Mag 200x)

Figure 8 is a optical photomicrograph of a polished cross-sectional of Specimen 7 showing the thickness corrosion layer and pits that developed. These photomicrographs show that the corrosion layer that developed on this torsion bar was not uniform and ranged in thickness from 0.4 mm to 0.8 mm or (0.016-0.031 in). The pit depths ranged between 0.2-0.3 mm or 0.008 to 0.012 inch. Their circumference of the pits ranged between 0.4 -0.6 mm or 0.016 to 0.024 in.

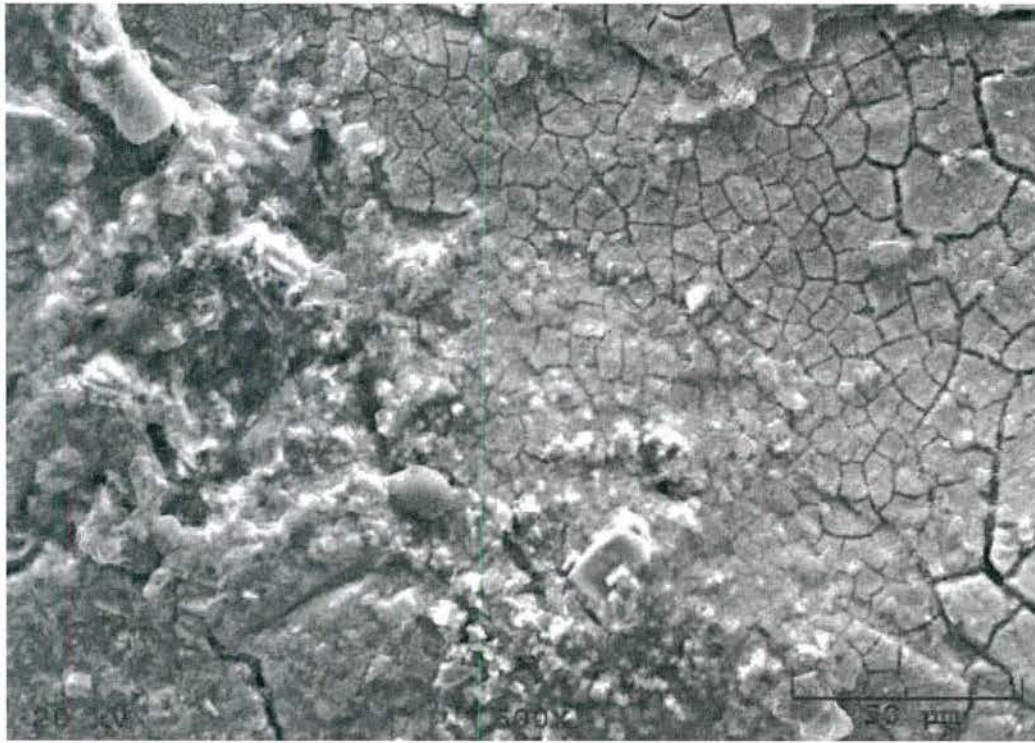
Figure 18 - SEM Photomicrograph of Surface of Specimen 12D (Mag 270x)

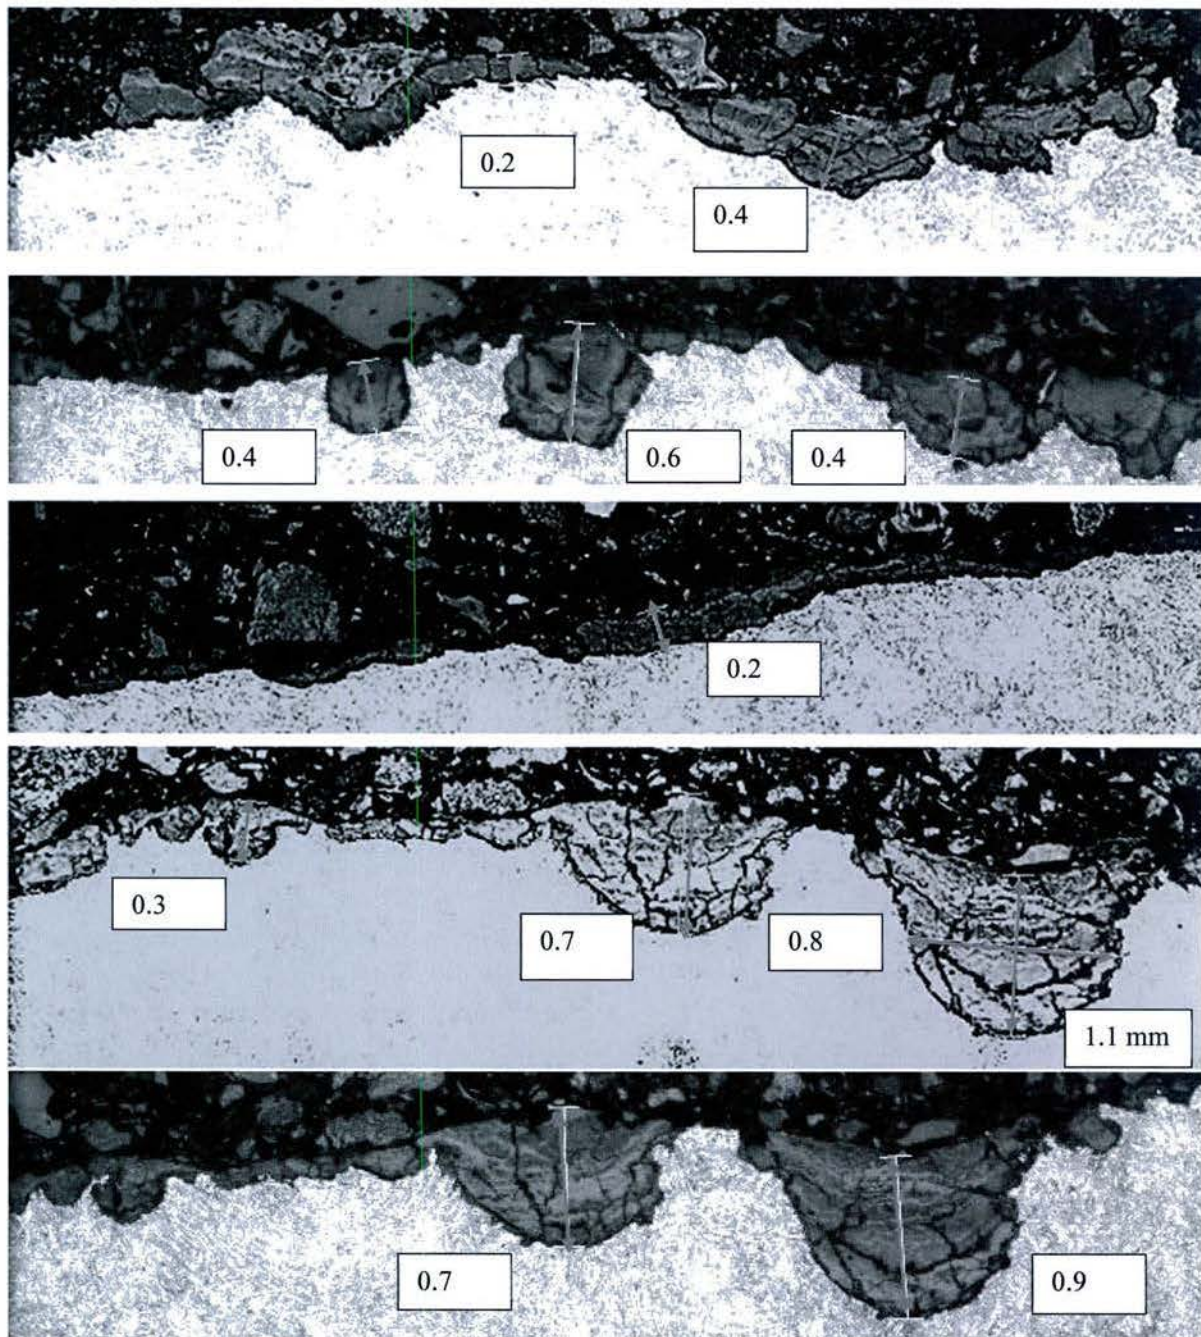
Optical photomicrographs of the polished cross-sections from Specimen 12D is contained in Figure 19. While the thickness of the corrosion layer that developed on this specimen was thinner than that observed on Specimen 7, ranging between 0.2 to 0.4 mm thick (0.008-0.016 in), the number and depth of the pit depths were significantly greater than those observed on Specimen 7. The pit depths on Specimen 12D ranged between 0.4 to 1.1 mm (0.016-0.043 inch) while the circumference of these pits ranged from 0.4 mm to 0.8 mm (0.016-0.031 inch). In addition, these cross-sectional photomicrographs from Specimen 12D show that the relatively large amount of pitting. The combination of the large number of pits observed along with the depth of these pits would significantly decrease in the mechanical and physical properties of the torsion bar if the pits are removed from the surface of the torsion bar by machining. For this reason, this torsion bar or any torsion bar with this type of corrosion layer is not a good candidate for remanufacturing.

Figure 19 - Cross-Sectional Optical Photomicrographs of Oxide Layer That Developed on Five Regions on Specimen 12D (Mag 200x top, 500x bottom)

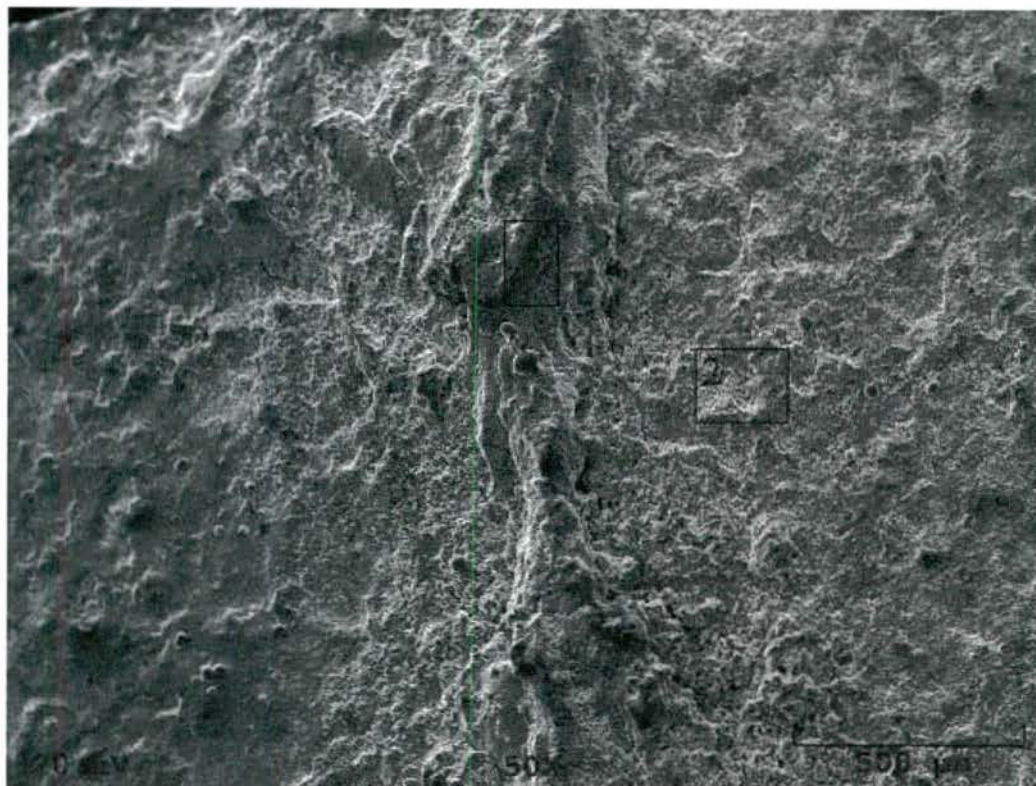
Figure 23 - SEM Photomicrograph of Heavy Corrosion Region in Specimen 15 (Mag 50x)

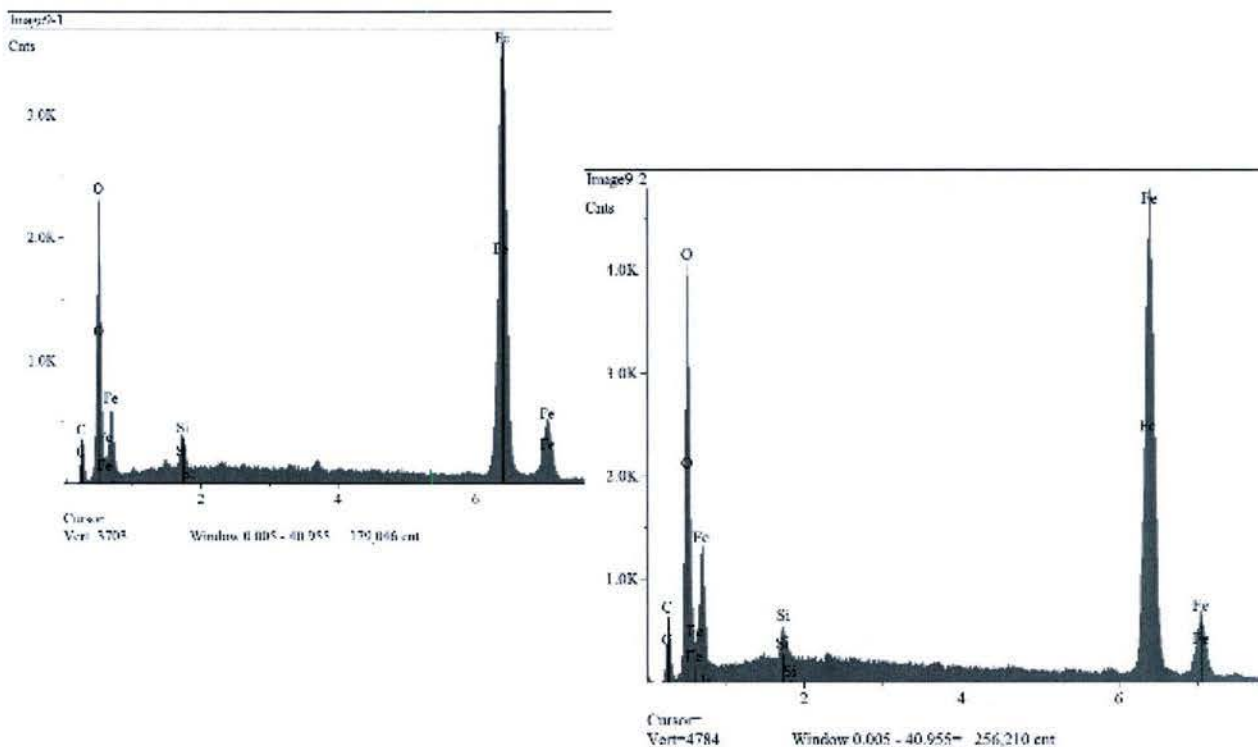
Figure 24 - Non-dispersive X-ray Analyses of Region 1 (Left) and Region 2

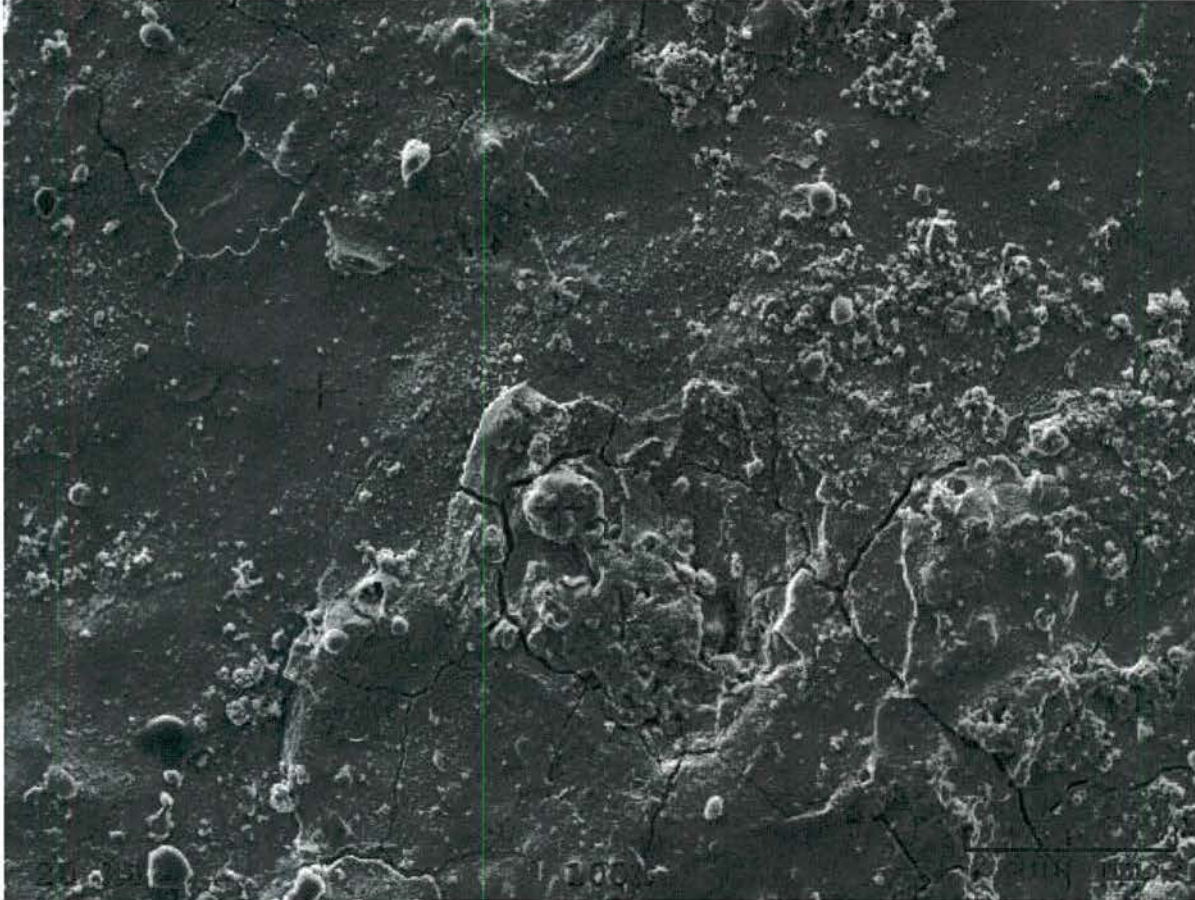
Figure 26 - SEM Photomicrograph of Surface of Specimen 11 (Mag 250x)

The SEM photomicrographs show that the corrosion layer that developed in Specimen 11 was similar to corrosion layer that developed on Specimen 15. Again the corrosion layer was porous and non-adherent, as evident by the significant number of cracks present in the corrosion layer. The cross-sectional optical

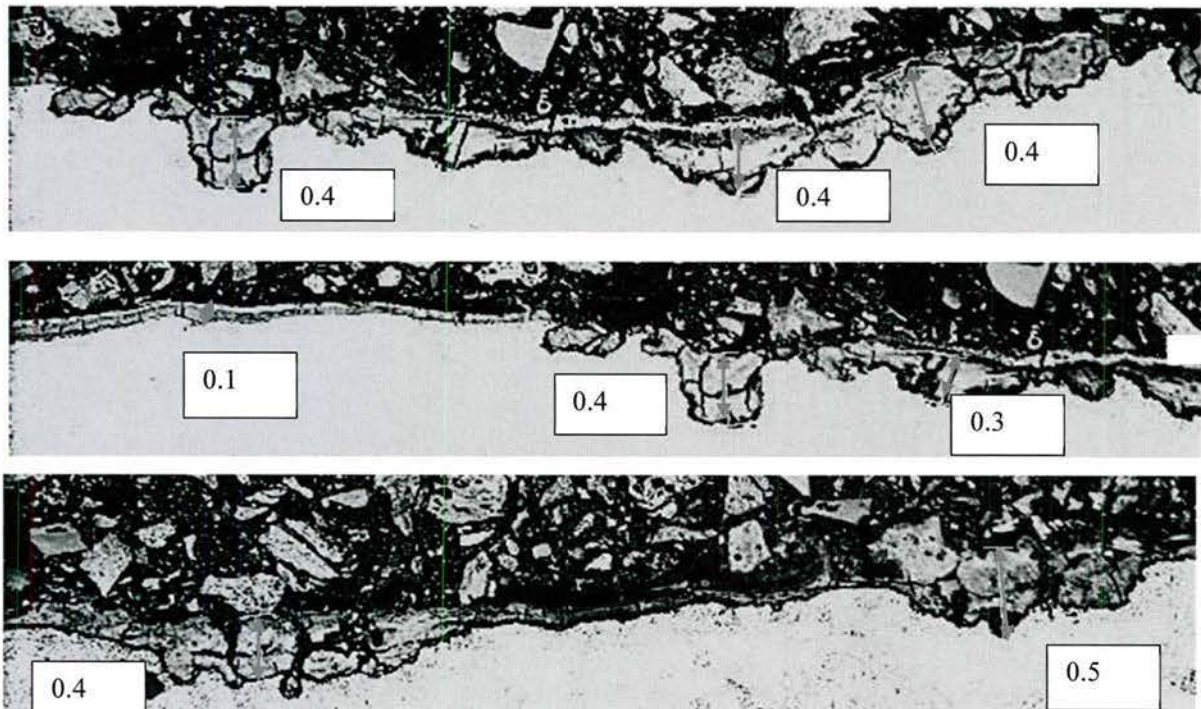
Figure 30 - Cross-Sectional Optical Photomicrographs of Oxide Layer That Developed on Three Regions on Specimen 11 (Mag 200x)

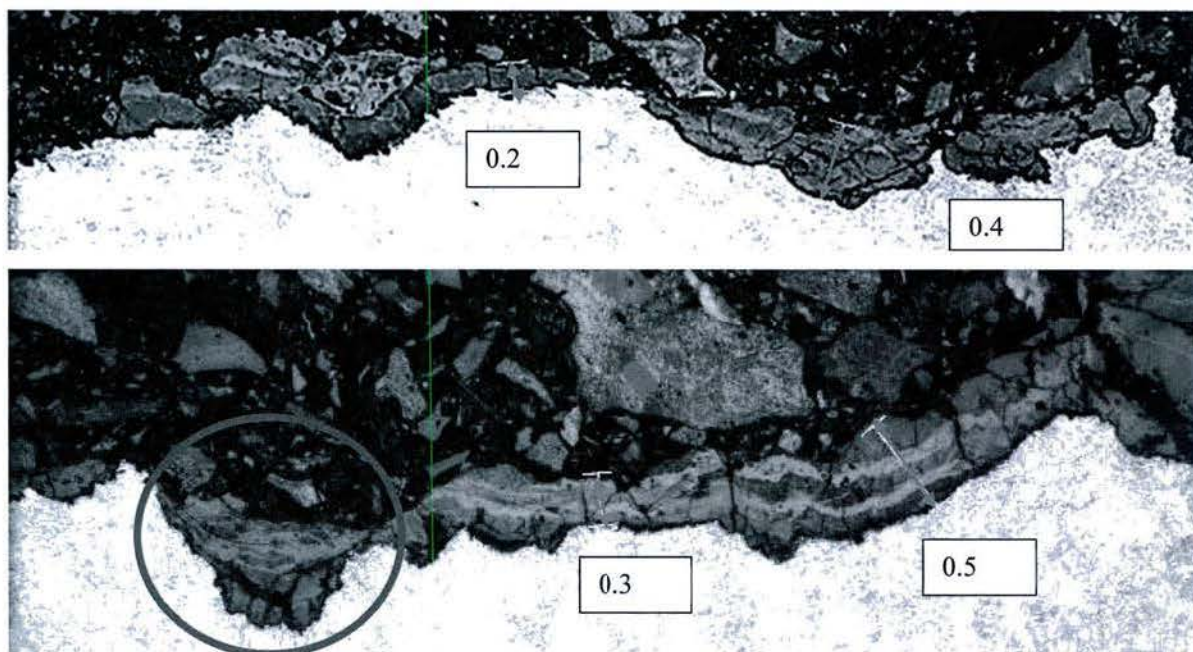
Figure 31 contains two cross-section optical photomicrographs of the corrosion layer that developed on Specimen 12D. Again, this specimen was from a region near the center of torsion bar 12 where the protective coating had been damaged exposing the 300M. These photomicrographs show that a 0.2 to 0.5 mm (0.008 to 0.020 inch) corrosion layer developed in this region. It is interesting to note that even though the corrosion layer had not flaked there was the beginning of a pit formation in the circled area in the lower photomicrograph.

Figure 31 - Cross-Sectional Optical Photomicrographs of Oxide Layer That Developed on Two Regions on Specimen 12B (Mag 200x top, 500x bottom)

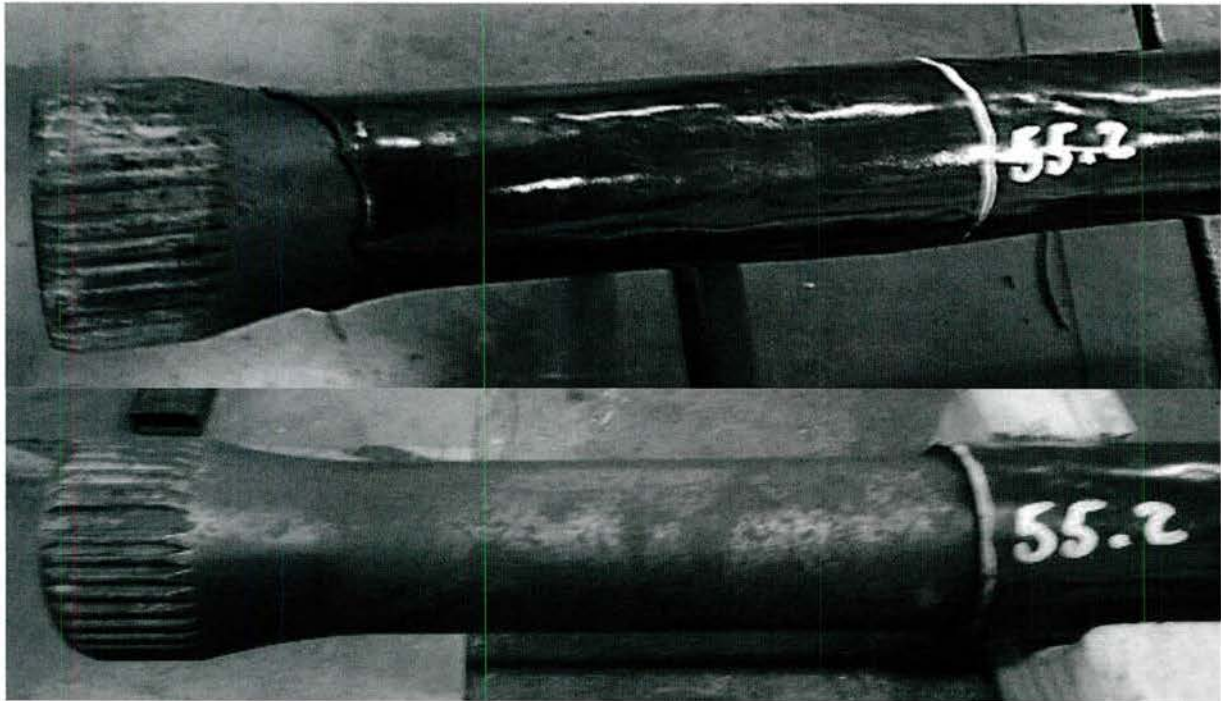
Figure 40 - Torsion Bar 55-2 Scrapped for Coating Disbonding. Top View Shows Coating Disbonding, Bottom View Shows Torsion Bar Surface after Coating Removal

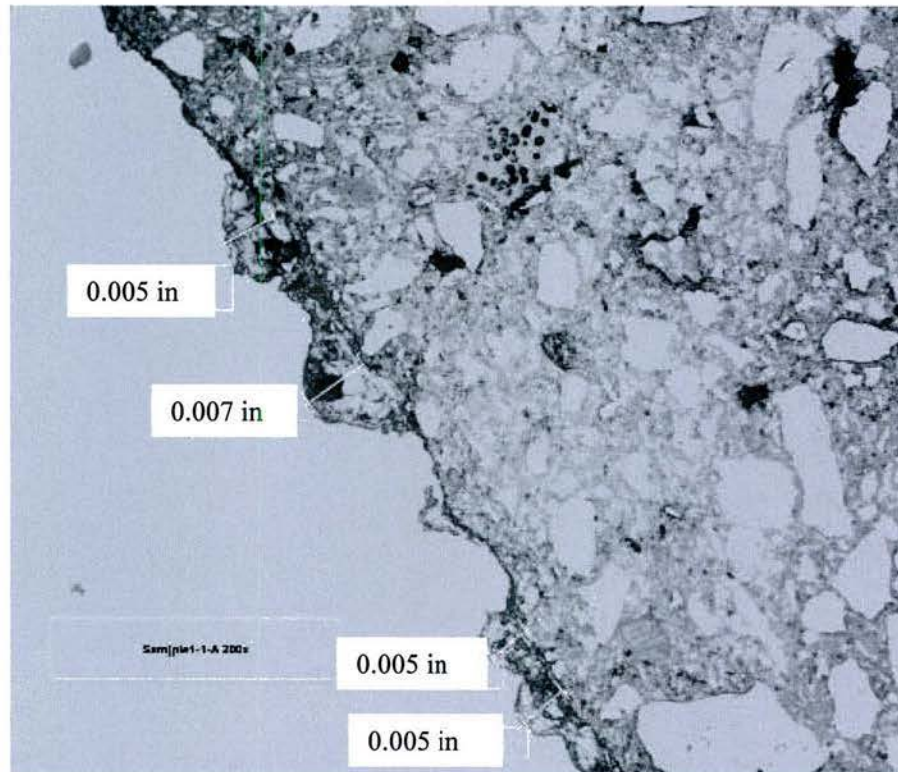
Figure 42 - Optical Photomicrograph of Oxide Layer on Region 2 of Torsion Bar 55-2 (Mag 200x)

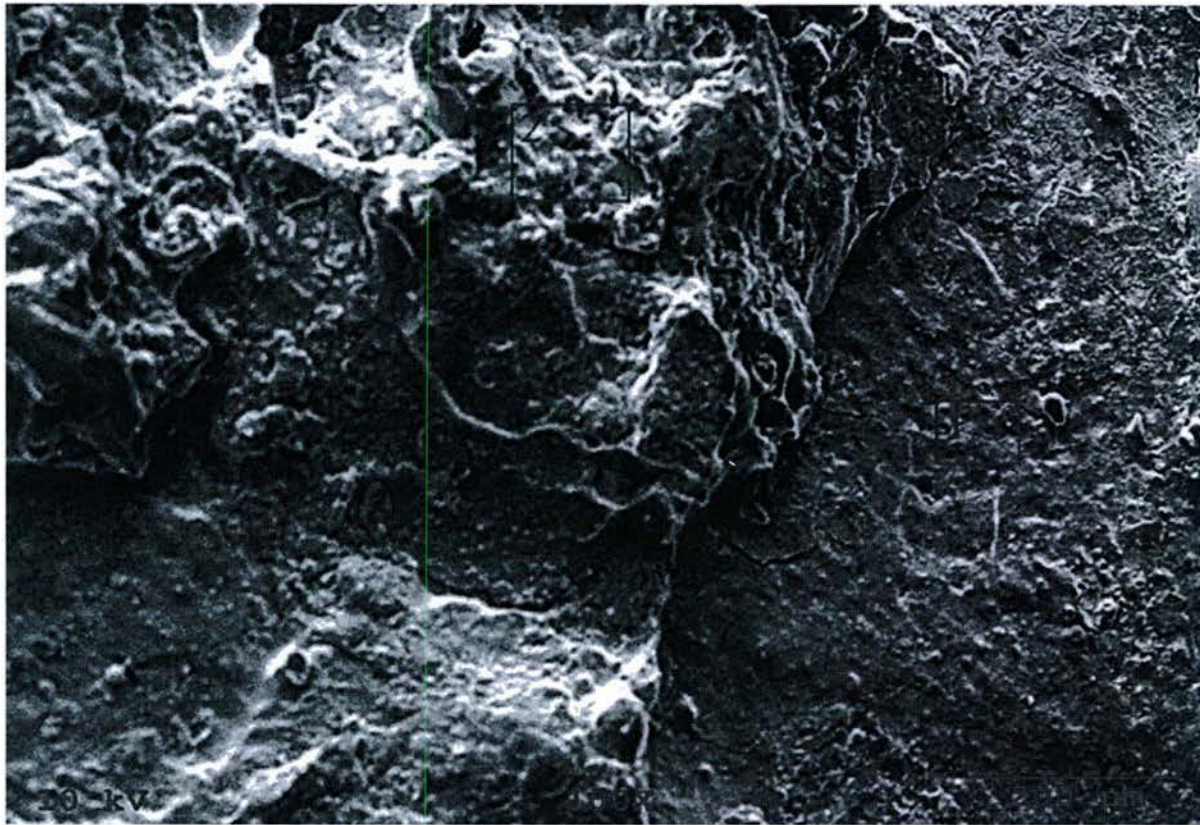
Figure 45 - SEM Photomicrograph of the Thick (left) and Thin (Right) Corrosion Layers on Torsion Bar 55-2

oxygen than the thinner layer. Thus, it contained more Fe_2O_3 and Fe_3O_4 than the thinner layer which consists mostly of FeO . It is interesting to note that there were cracks present in both the thick and thin oxide layers.

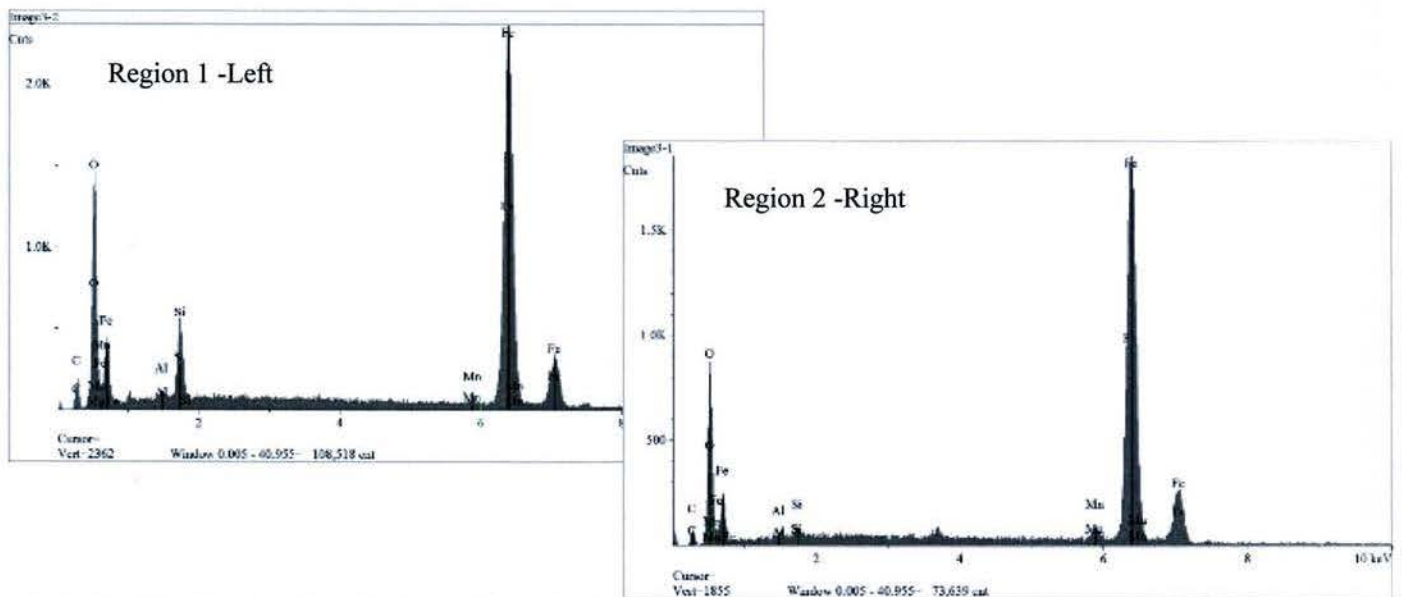
Figure 44 - Non-dispersive X-ray Analyses of Corrosion Layer on Torsion Bar 55-2

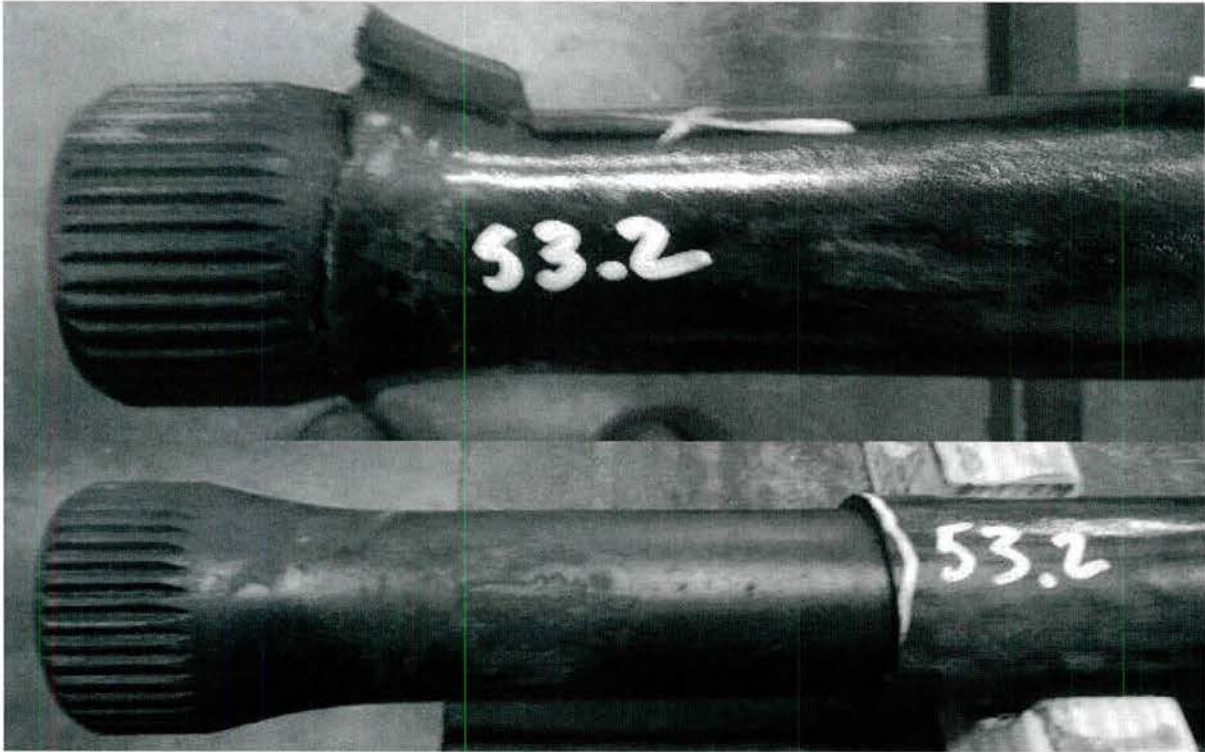
Figure 46 - Torsion Bar 53-2 Scrapped for Coating Disbonding. Top View Shows Coating Disbonding, Bottom View Shows Torsion Bar Surface after Coating Removal

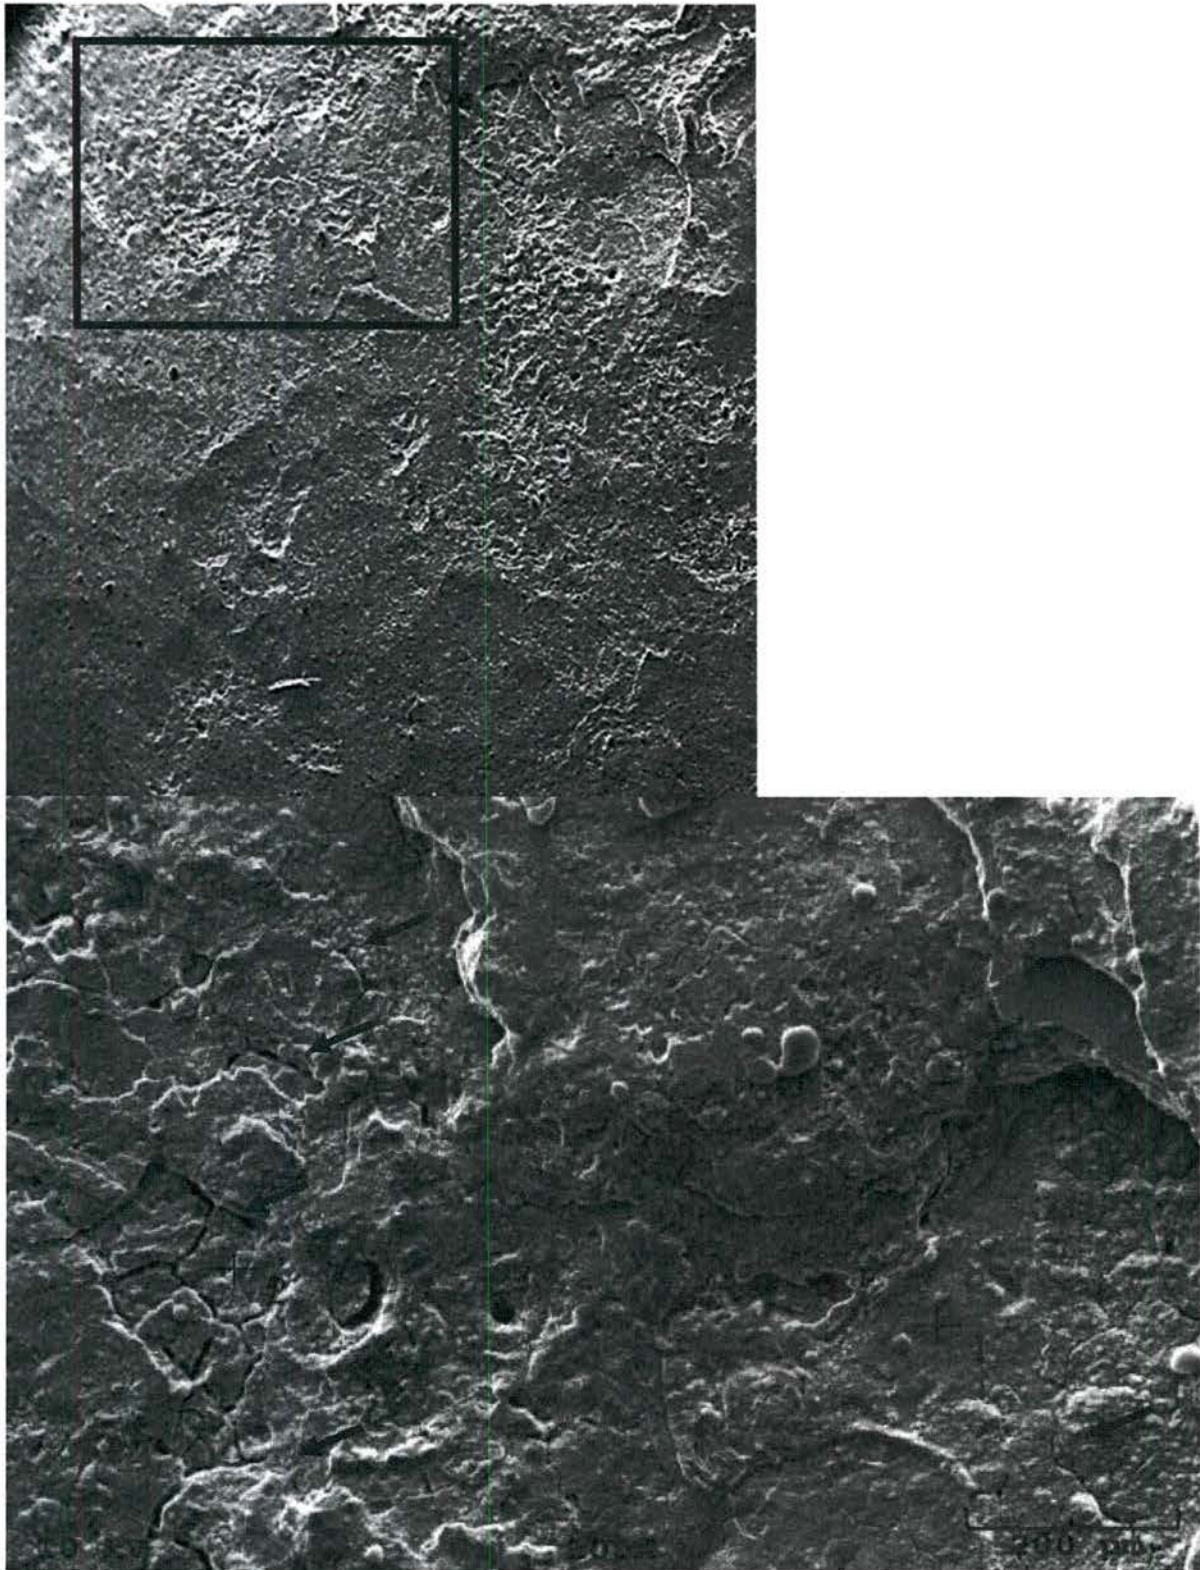
Figure 48 - Higher Magnification SEM photomicrograph of Surface Oxide from Torsion Bar 53-2 (Mag 100x)

Scanning electron microscopy (SEM) photomicrographs of the oxide layer that developed on the surface of this torsion bar are shown in Figure 48. Figure 48 shows that a continuous oxide layer developed on the surface of torsion bar 53.2. Again the oxide that developed was non-protective showing areas of delamination (Region within square in Figure 48) and cracks (arrows in Figure 48).

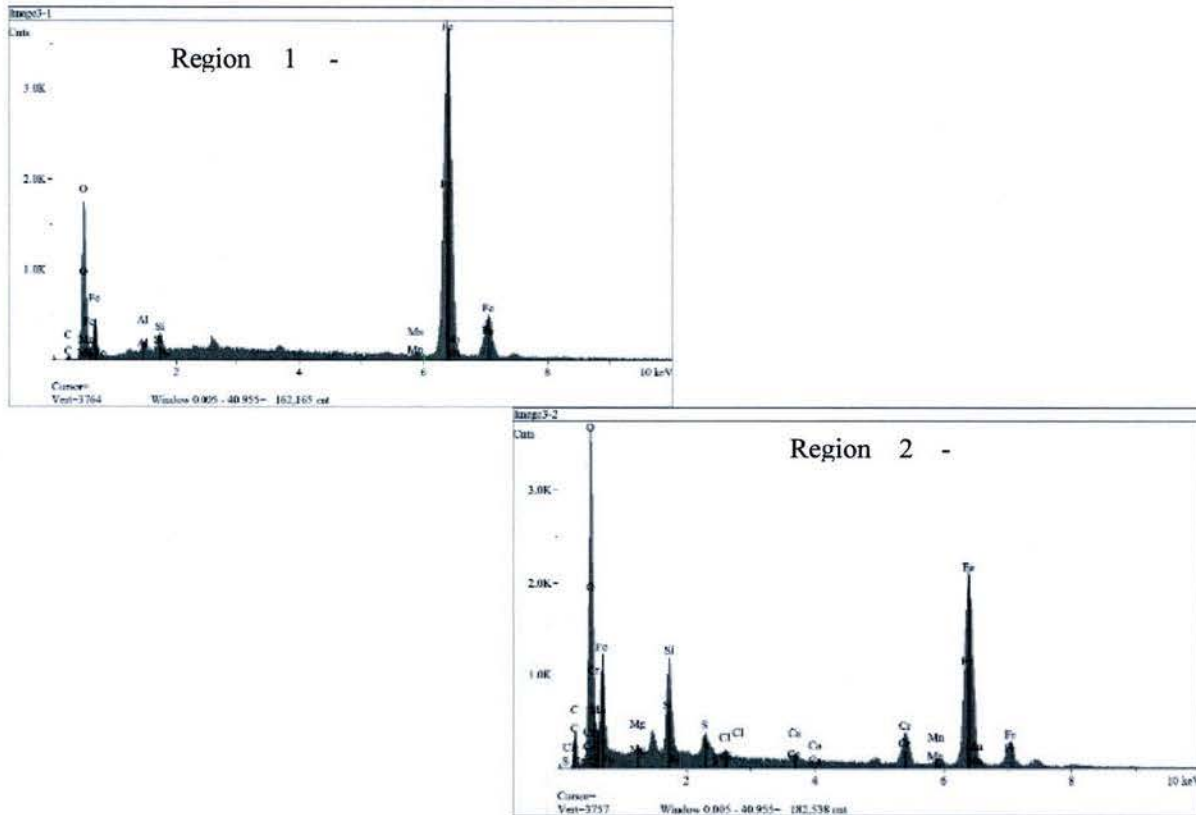
Figure 49 - Non-dispersive X-ray Analyses of Corrosion Layer on Torsion Bar 53-2

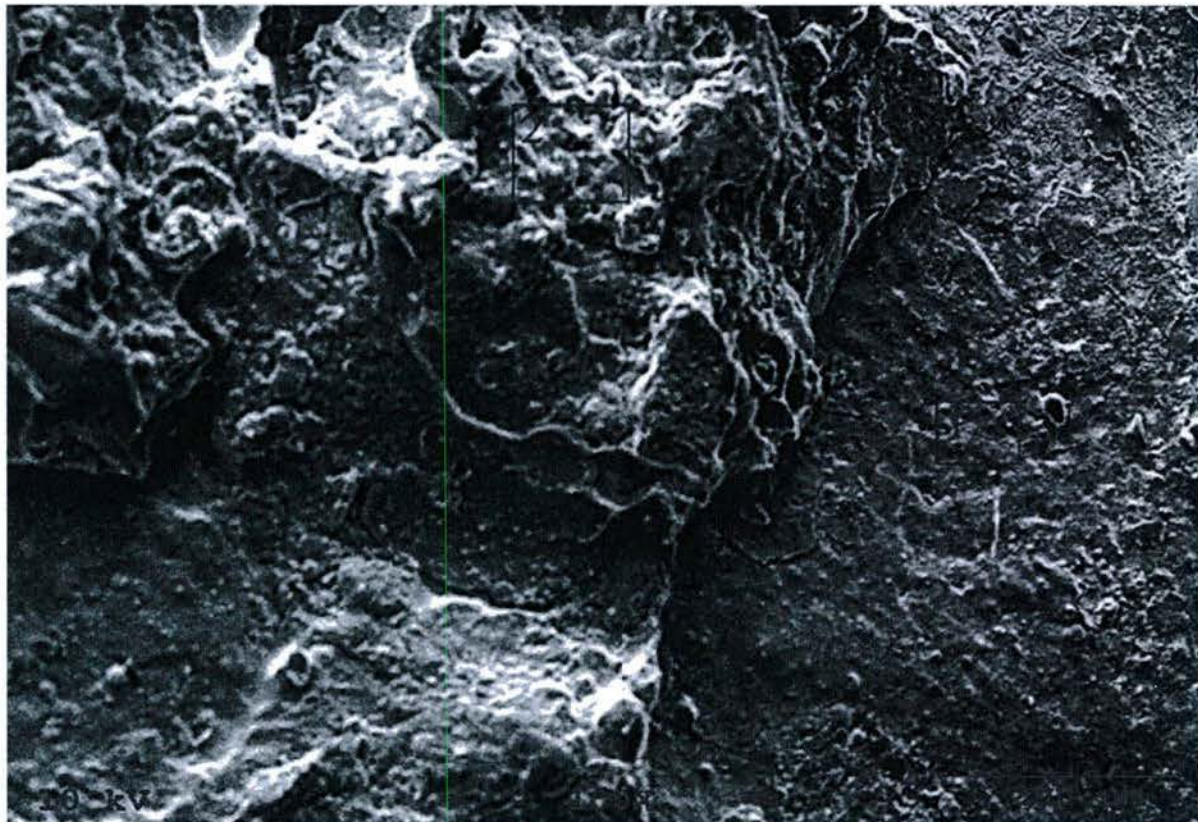
Figure 55 and the non-dispersive X-ray analyses in Figure 54 showed that the thick and thin corrosion layers consisted of iron oxide. The difference between the two layers was the thicker layer contained more oxygen than the thinner layer. Thus, it contained more Fe_2O_3 and Fe_3O_4 than the thinner layer which is consists mostly of FeO . It is interesting to note that there were crack present in both the thick and thin oxide layers.

Figure 55 - SEM Photomicrograph of the Thick (left) and Thin (Right) Corrosion Layers on Torsion Bar 55-2

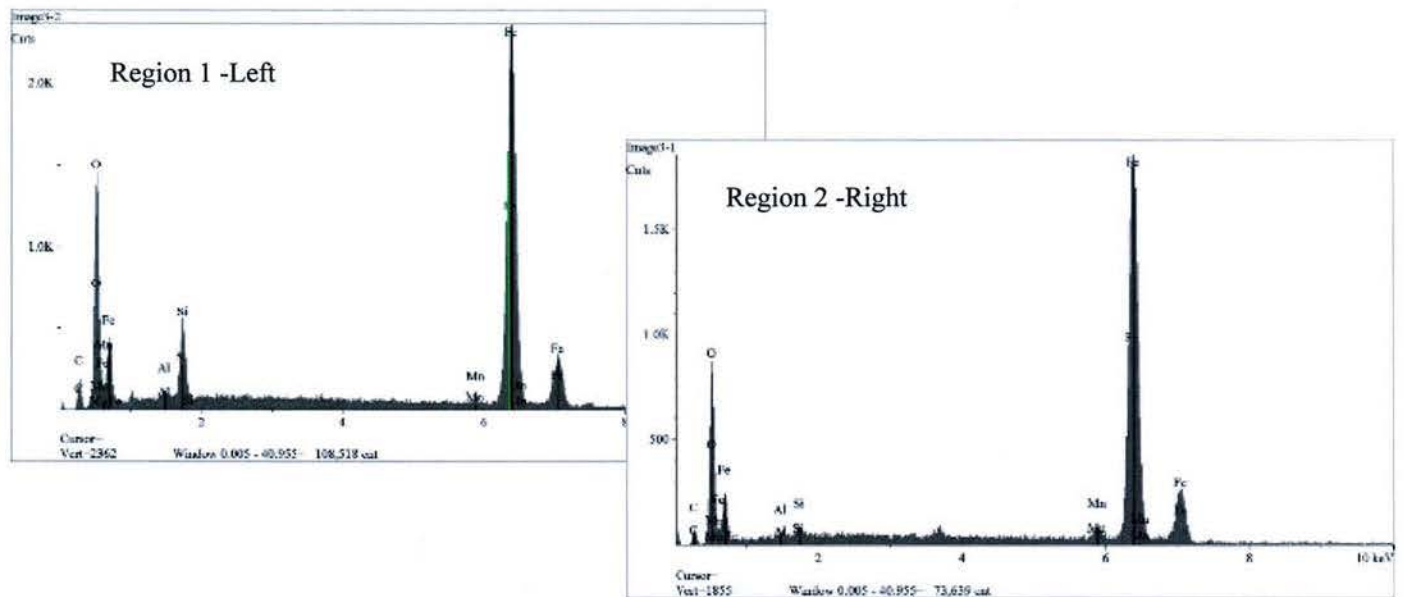
Figure 54 - Non-dispersive X-ray Analyses of Corrosion Layer on Torsion Bar 55-2
